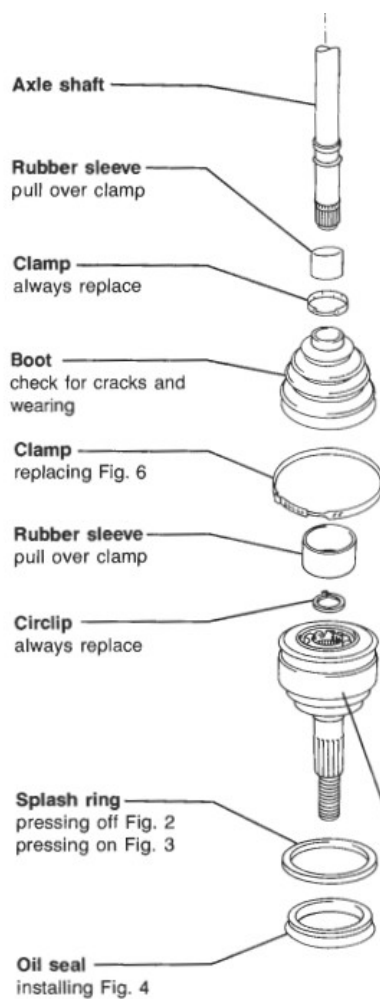
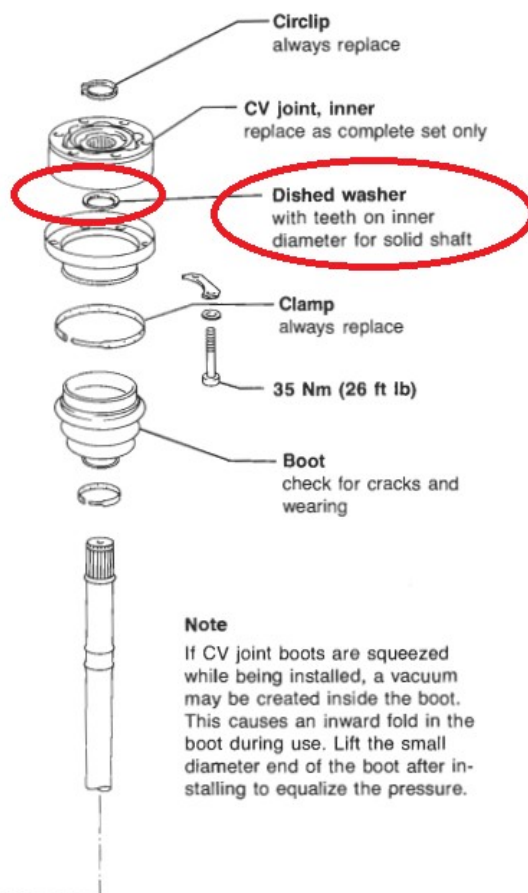
If CV joint boots are squeezed while being installed, a vacuum may be created inside the boot. This causes an inward fold in the boot during use. Lift the small diameter end of the boot after installing to equalize the pressure.

CV joint, outer
replace as complete set only
installing: insert circlip,
press joint on shaft until
circlip engages
